**URGENT DEVICE
CORRECTION**

15 December 2005

Re: COLLEAGUE VOLUMETRIC INFUSION PUMP, PRODUCT CODES: 2M8151 & 2M8151R;
COLLEAGUE 3 VOLUMETRIC INFUSION PUMP, PRODUCT CODES: 2M8153 & 2M8153R;
COLLEAGUE CX VOLUMETRIC INFUSION PUMP, PRODUCT CODES: 2M8161 & 2M8161R;
COLLEAGUE 3 CX VOLUMETRIC INFUSION PUMP, PRODUCT CODES: 2M8163 & 2M8163R
FRENCH COLLEAGUE VOLUMETRIC PUMP, PRODUCT CODES: DNM8151 & DNM8151R
FRENCH COLLEAGUE 3 VOLUMETRIC PUMP, PRODUCT CODES: DNM8153, & DNM8153R

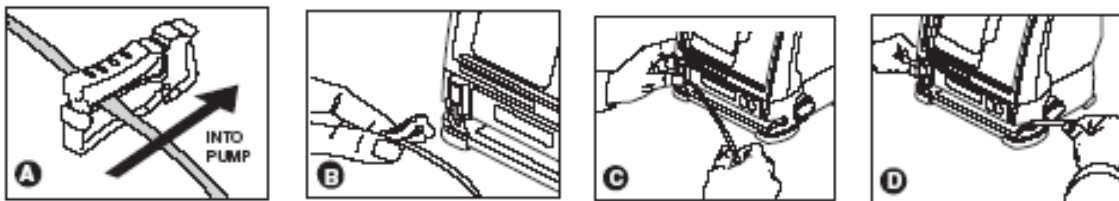
- When loading the IV set, pull the administration set taut and slide it all the way into and along the tubing channel (Figure C and D). The pump pulls in the keyed slide clamp, then loads the administration set into the pumping mechanism. The pump module displays **LOADING** and then **STOPPED**.

If the above instructions are not followed, there is a potential for misaligning the pump chamber components, which may result in an under-delivery condition.

- Never insert tools or other objects into the tubing channel when attempting to load or unload the administration set.
- Never use the Manual Tube Release to load or unload the administration set during normal operation.
